Manhole Inspection Summary

Manhole # S02CC2005MH

Insp Date: **8/14/06 12:00 AM**

Location Address: **6708 CROSS COUNTRY BLVD**

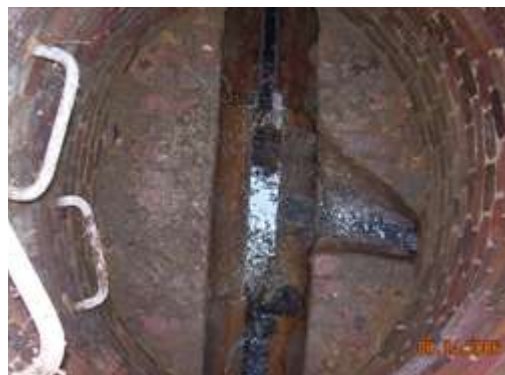
Top View

Infiltration: ☐ None ☒ **Joint** ☐ Cracks ☐ Mortar ☐ Roots ☐ Wall

Infiltration: ☐ None ☐ Joint ☐ Cracks ☒ **Mortar** ☐ Roots ☒ **Wall**

☐ Parged ☒ **Debris** (not Condition related)

☒ **Debris** (not Condition related)

Corbel and Barrel infiltration. Bench and Channel debris.

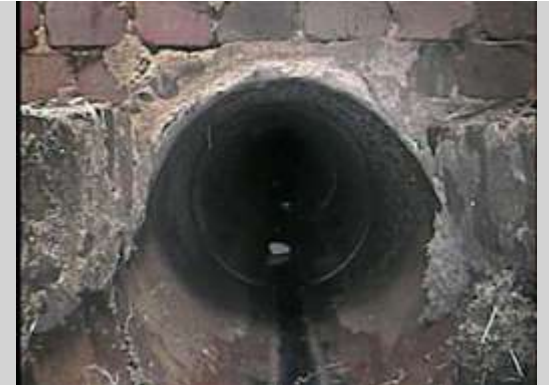
12 in. Circular Gravity Sewer Pipe Out @ 12 O'Clock

Condition: ☐ Sound ☐ Cracked ☒ **Root Intrusion** ☐ Deteriorated ☐ Leaks ☐ Debris

Channel root intrusion.

Infiltration: **None** Pipe Seal Cond: **Roots**

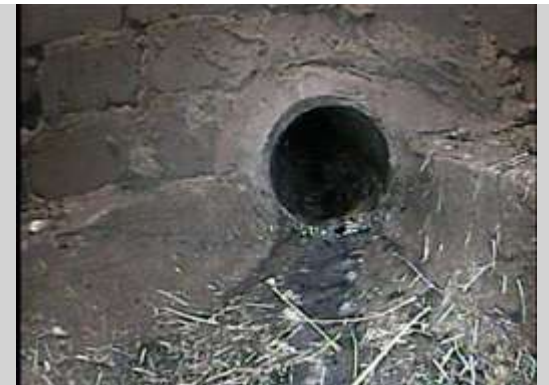
4 in. Circular Gravity Sewer Pipe In @ 3 O'Clock

Deposits: ☐ None ☒ **Mud** ☐ Sludge ☒ **Debris** ☒ **Grease**

Silt Depth: **0.5** (in.) Deposits Extent: **Light**

Infiltration: **Evidence** Pipe Seal Cond: **Unknown**

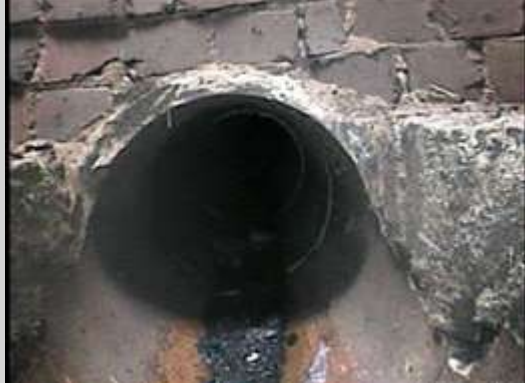
12 in. Circular Gravity Sewer

Deposits: ☐ None ☒ **Mud** ☐ Sludge ☒ **Debris** ☐ Grease

Silt Depth: **0.5** (in.)

Deposits Extent: **Light**
